FIELD CHANGE ORDER

Ref. No. : 00 135 004
Date : May 1998
Product group : 742

OPTIMUS 50 / 65 / 80 RAD – R/F

Error combination 00XI + 00M3

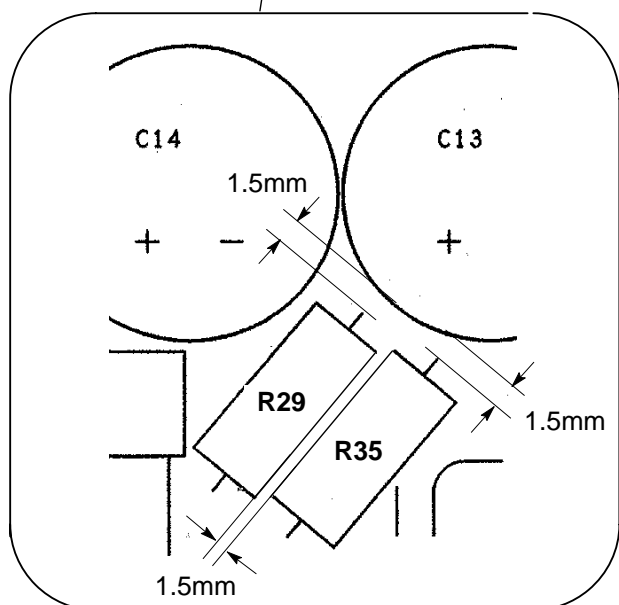
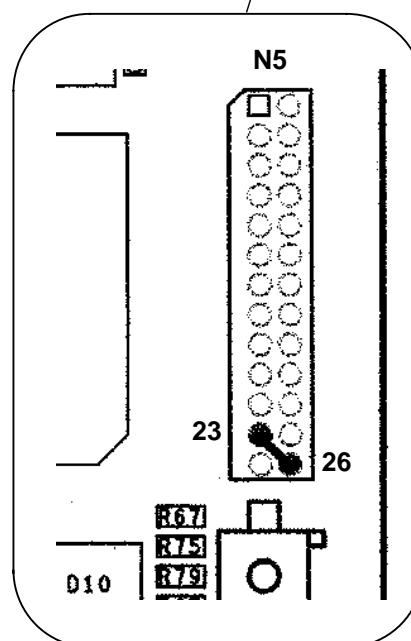
The processor on the rotor control has a debug port. One of the signals is not connected to a pull up resistor. The floating signal leads to the error combination 00XI + 00M3. It happens only once during turn on, not during normal operation.

3. Check that the connecting wires of resistors
R29 / R35 have a distance of at least **1.5 mm** to the
capacitors C13 and C14.

Also between the resistors itself a gap of **1.5 mm**
is necessary. see sketch (page 3)

When the resistors come in contact to the capacitors or
have mechanically contact to each other this can lead to
a shortcircuit and defect of the rotor control.

1. Switch Off the generator.
2. Open the Rotor Control unit,
(back side of generator cabinet)
– solder a link between N5:23 and N5:26 of the
EY 100 PCB. see sketches (page 3).
