FIELD CHANGE ORDER

Issued by : DMC Hamburg
Axel Duve **signed**
Publication No. : 4512 980 58281

OPTIMUS 50 / 65 / 80 RAD - R/F - C

Error combination 02WK + 02HG + 02HH + 00XO

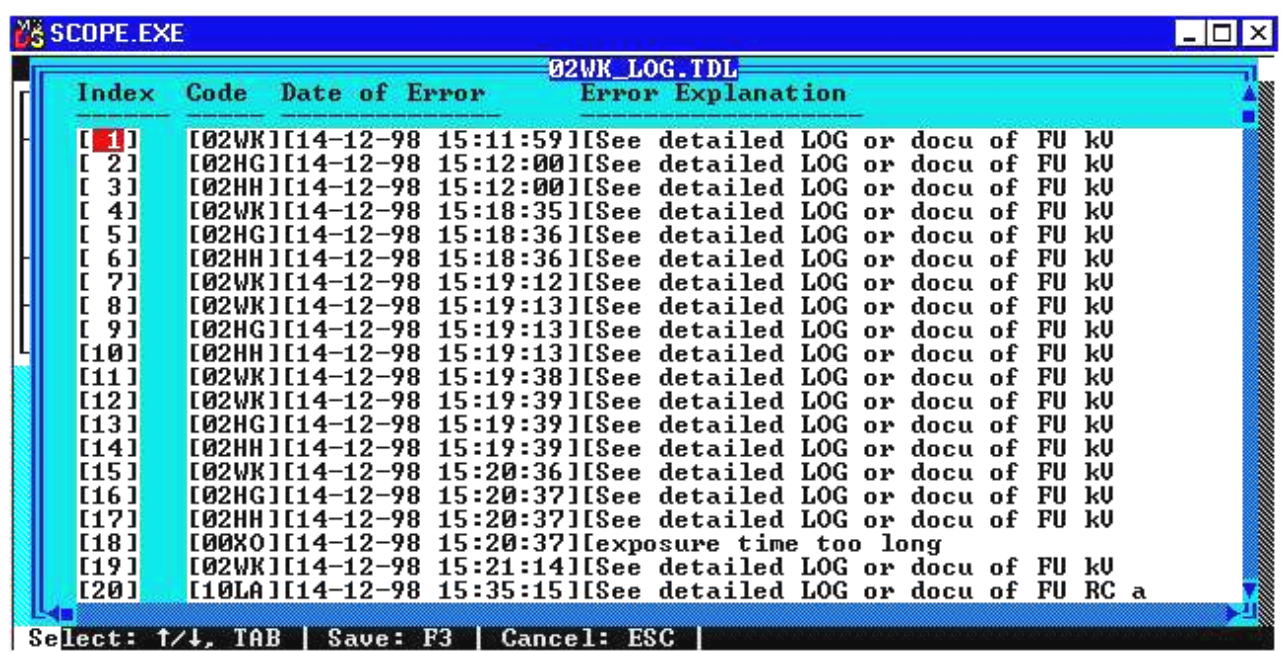
XRGSCOPE >> Faultfind >> Logging Table >> Error Log >> Error Log Index

In case of a relay malfunction there will be no kV with exposure command. Error codes 02WK, 02HG, 02HH and 00XO might appear in different combinations, see following XRGSCOPE screen:

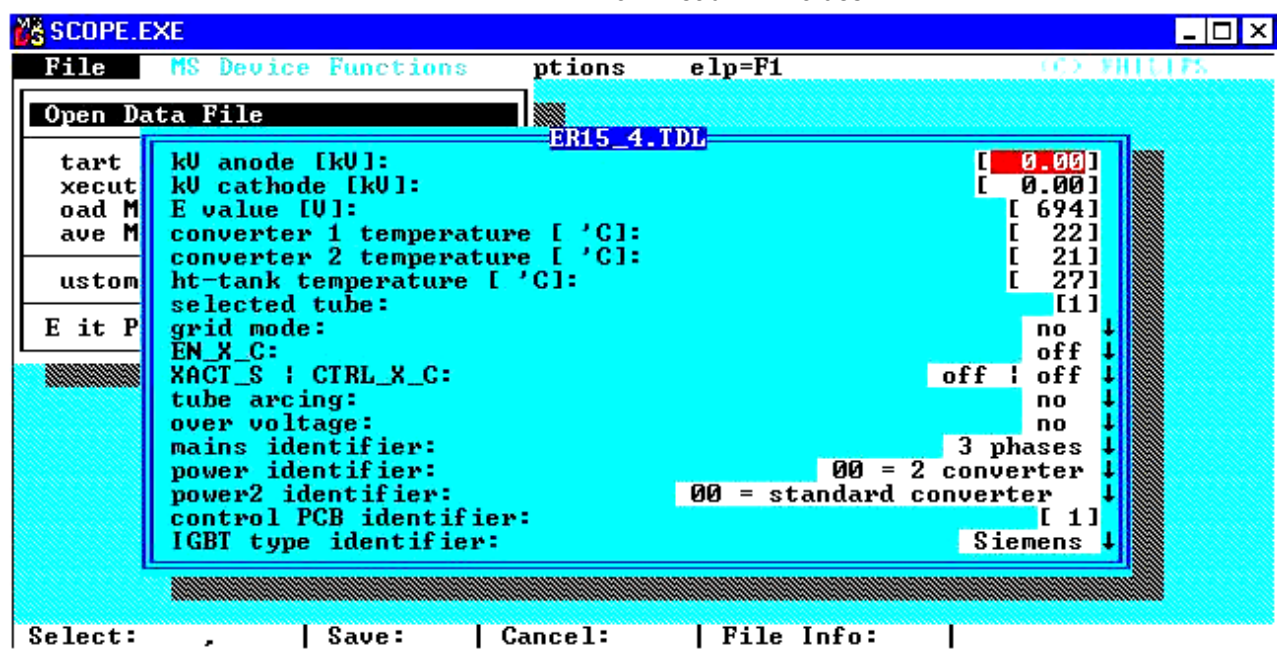
XRGSCOPE >> Faultfind >> Logging Table >> Error Log >> Select Error Detail >> 15 >> <F2>
 Error Log >> Error Log Detail >> Error Detail of kV >>
 Error : Read HW Values

EN_X_C is **off**. This confirms the relay contact malfunction.

If the malfunction of the relay has been confirmed replace PCB CU EZ139.
Before doing so the CU Complete download has to be carried out (details see Service Manual).
Set the battery jumper of the new PCB CU to the **ON** position, then insert the new PCB.
Turn on the generator. Set XRGSCOPE >> Program >> **Date and Time**.
Reload the CU Complete data file. The generator should come up as before.

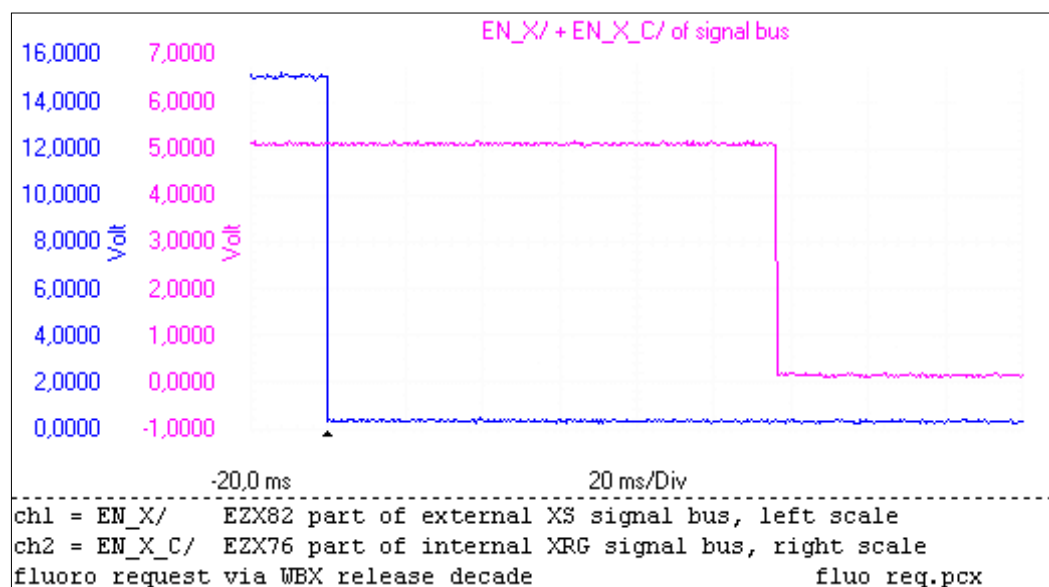
Fluoroscopy request via release decade adaptation unit WB

The signal behavior should be identical to the following oscilloscope screenshots:
