FIELD CHANGE ORDER

Reference No. : 00 135 016
Date : August 2001
Product Group : 742

OPTIMUS 50 / 65 / 80

Error 00TH during tube adaptation

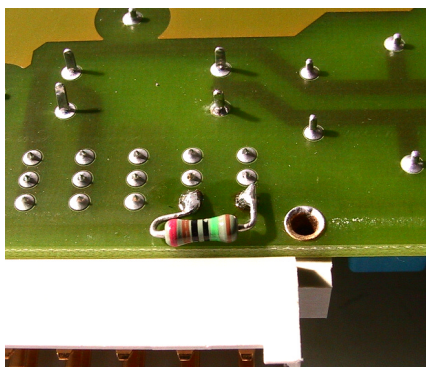
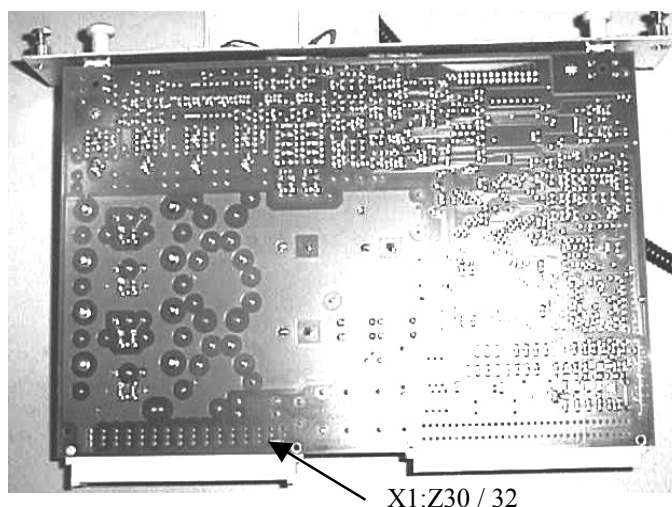
Symptom : Error 00TH during tube adaptation
Cause : The optocoupler B2 operates at its tolerance limits on board of PCB mA control EZ 119 (4512 108 05948). This can lead to intermittent problems during tube adaptation.
Remedy : Reduction of the input current for the optocoupler by soldering on an additional resistor parallel to the optocoupler diode.

1. Switch off the generator.
2. Open the cabinet, wait at least 1 minute, then pull out PCB EZ 119.
3. Solder on the resistor between contacts X1:B30 or Z30 and X1:B32 or Z32, see sketch for details.
4. Reinstall the PCB in the generator rack.
5. Close the cabinet.
6. Test all applicable functions.
